# **BLACK SLUICE**

## **INTERNAL DRAINAGE BOARD**

# **Northern Works Committee Meeting**

## NORTHERN WORKS COMMITTEE INSPECTION Tuesday 2nd July 2024

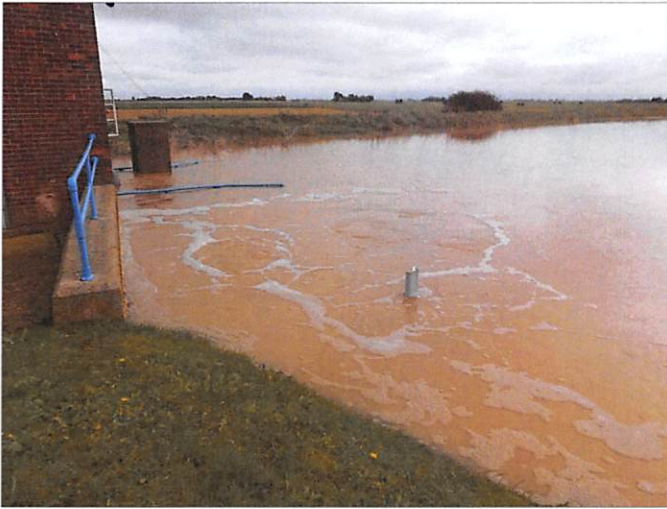
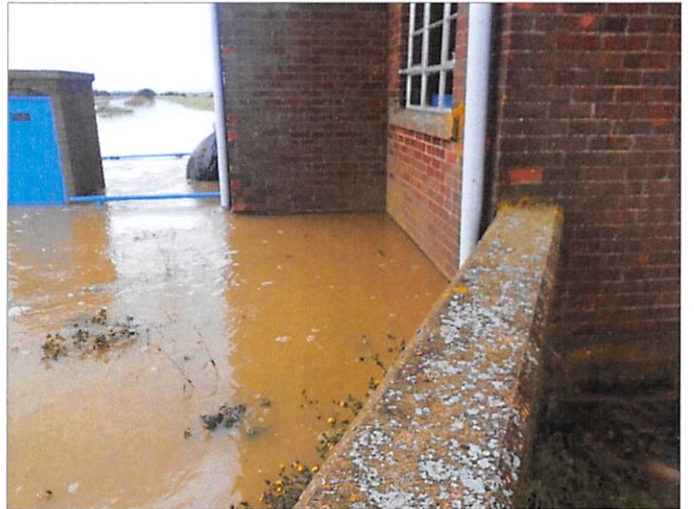
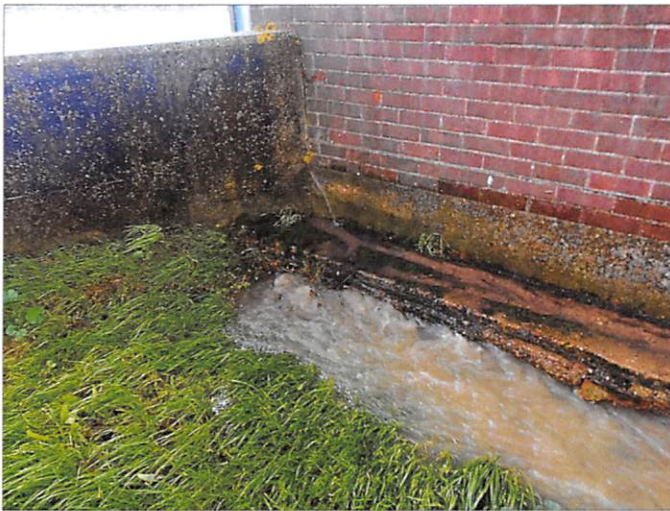
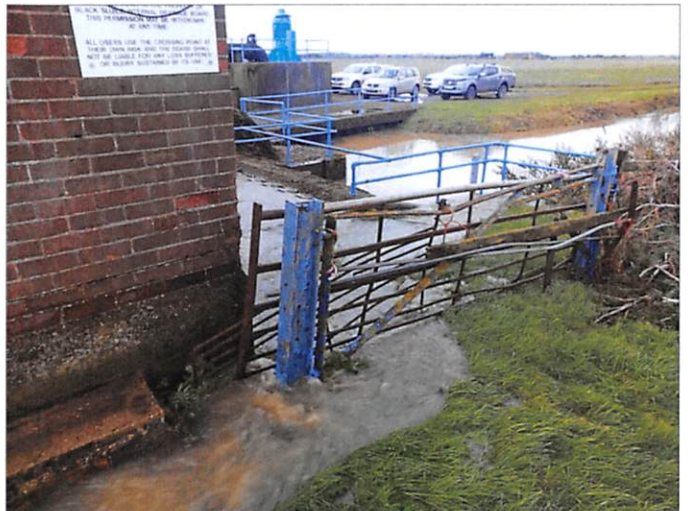
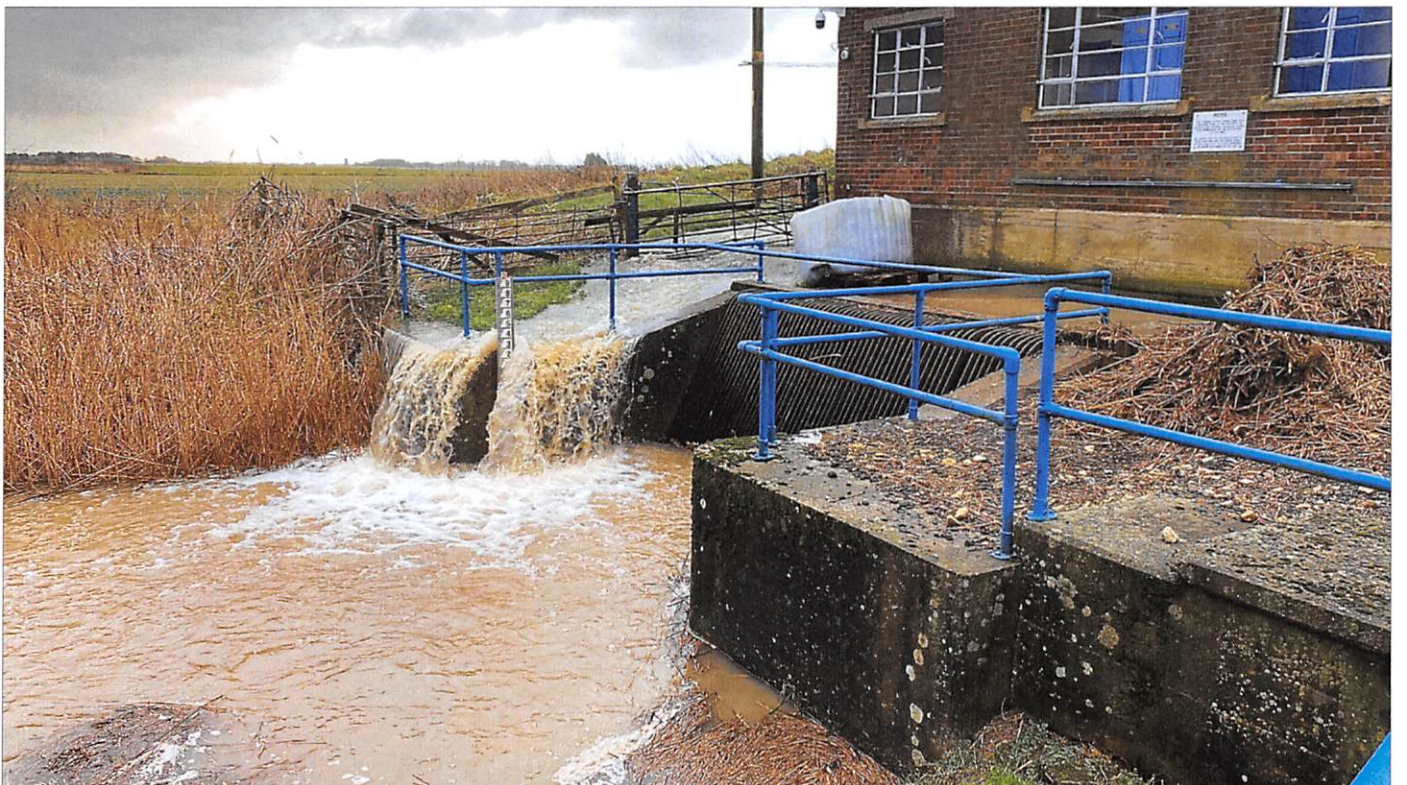
**Point of Interest A - Ewerby Fen Pump Station - Storms Babet & Henk**

As discussed at previous meetings, ongoing issues with flows around or through Environment Agency main river raised embankments continues to be a problem at four of the Boards pumping stations at Ewerby Fen, South Kyme Fen, Trinity College and Damford Grounds.

Initially identified in 2019, during heavy rainfall events and higher water levels in main river outfalls, there are increased flow paths of water around these pumping stations.

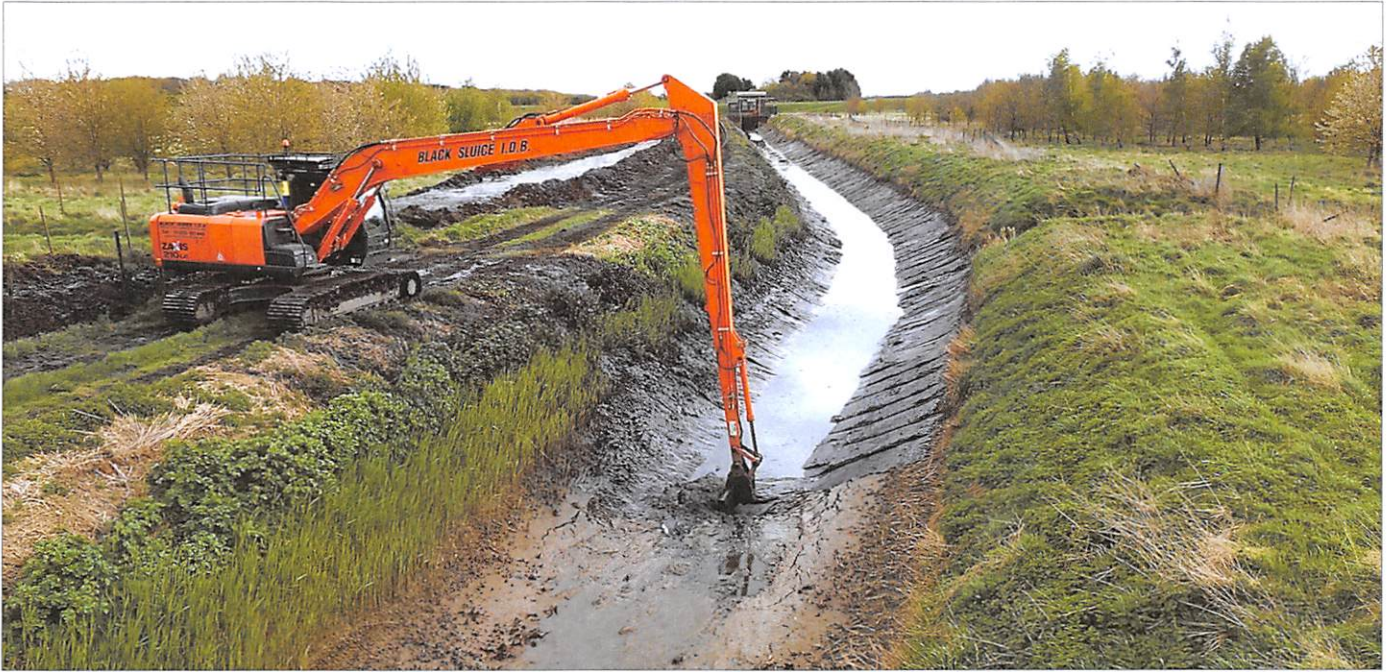
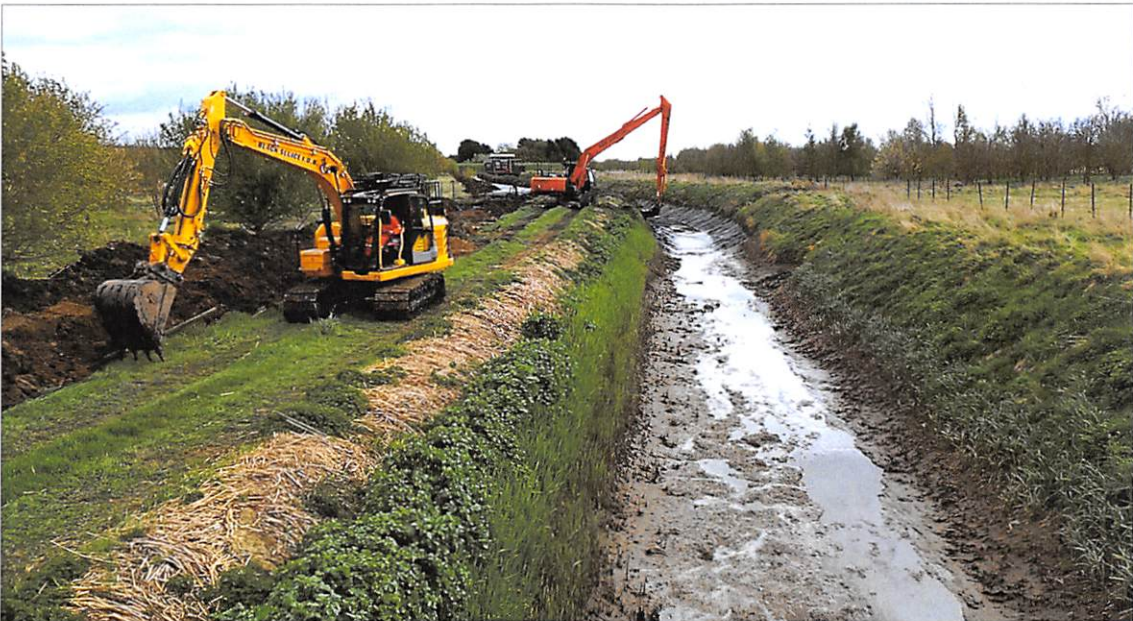
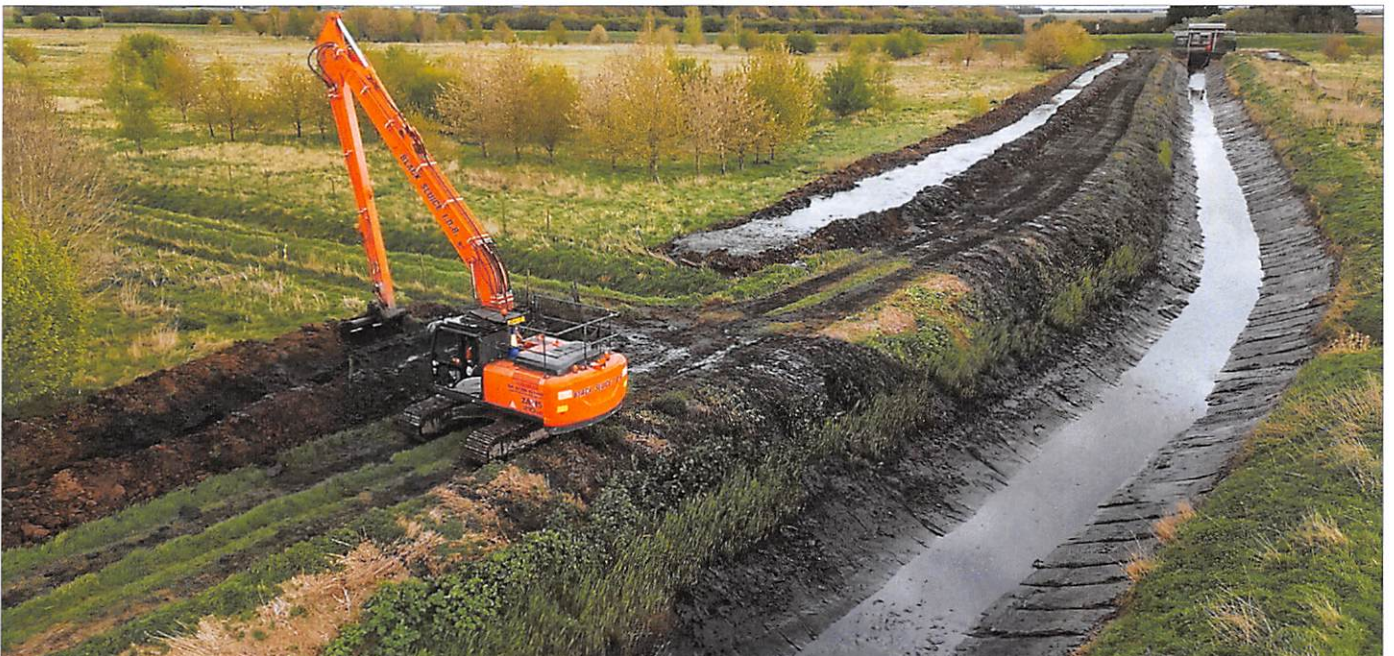
**1 - Damford Grounds PS –view works, discuss proposed works**

Photos on previous page showing works completed to desilt the upstream 550m section of watercourse from the pumping station to the farm access track.

After placing a dam across the watercourse to reduce water levels, two excavators are used, one for cradge works and one for desilting.

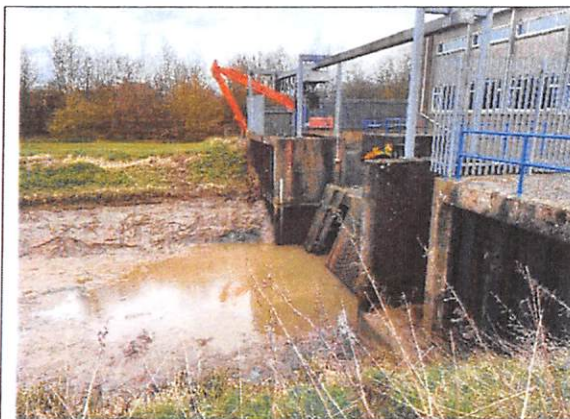
Photograph 1: Pumping Station Inlet

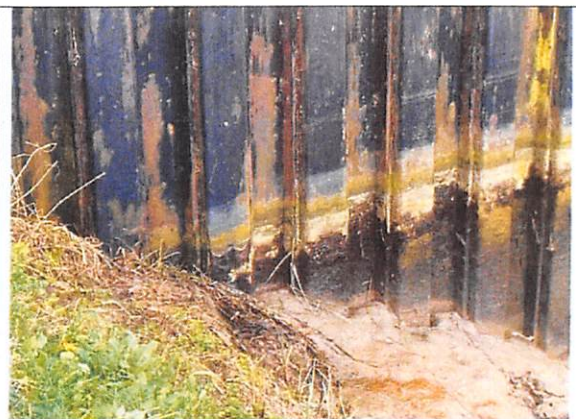
Photograph 2: LHS wing wall – test areas

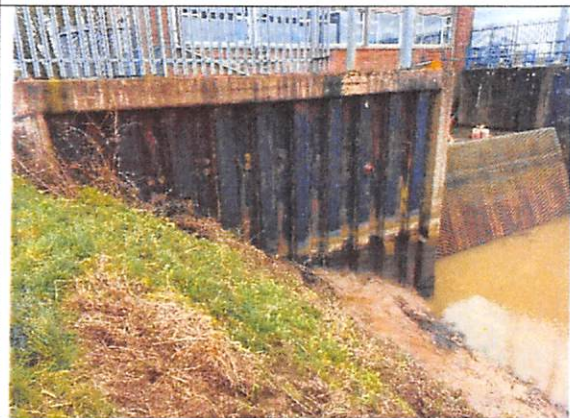
Photograph 3: LHS wing wall – test area

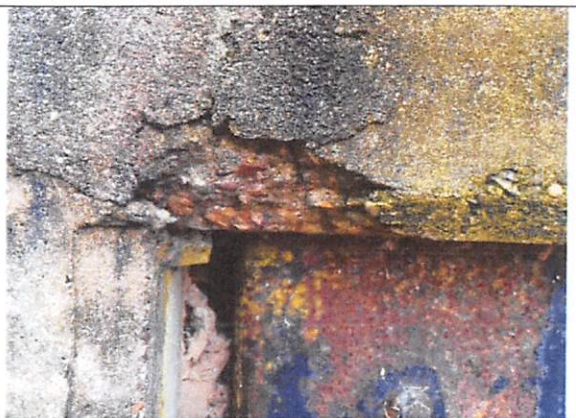
Photograph 4: LHS capping beam - localised spalling

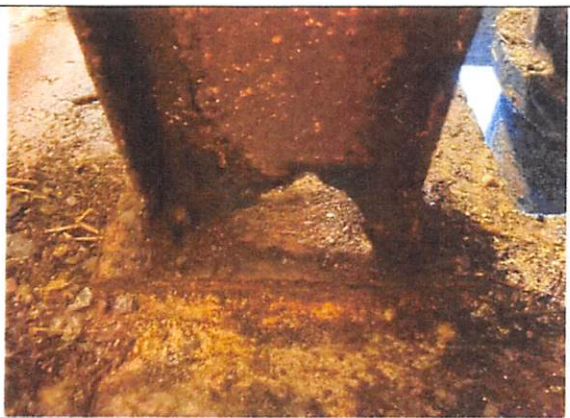
*All 4no pump support stanchions should be replaced, along with general refurbishment of the pump support steelwork. In the interim consideration should be given to installing a temporary prop where one stanchion has failed.*

Photograph 5: Stanchion at lower slab level – hole

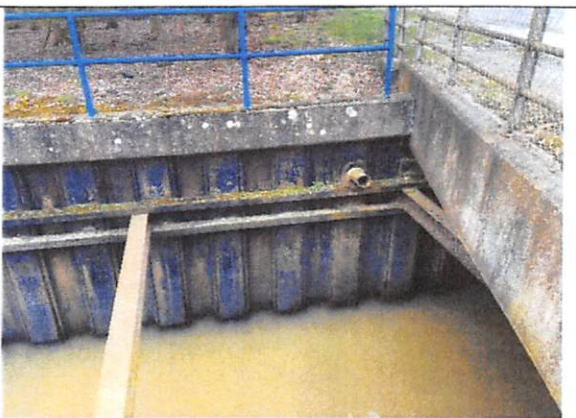
Photograph 6: Outfall - corrosion to steel bracing

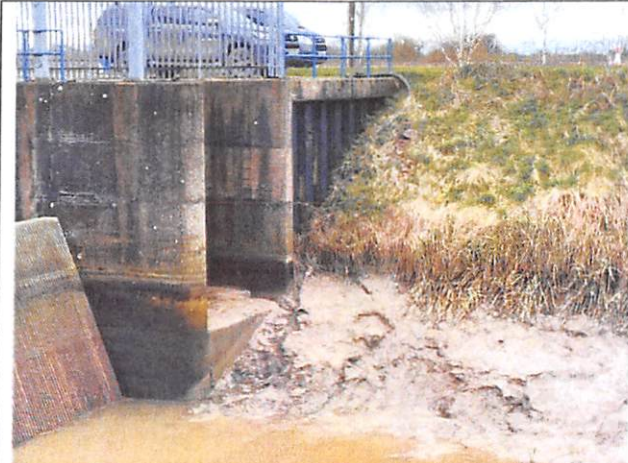
Photograph 7: RNS wing wall – pile section mostly buried

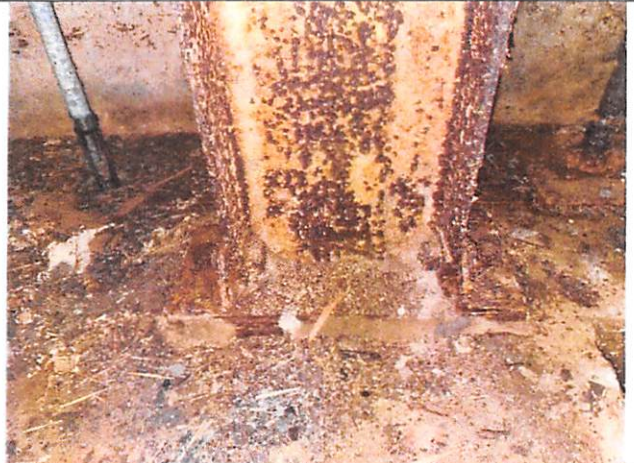
Photograph 8: Stanchion at lower slab level – typical condition

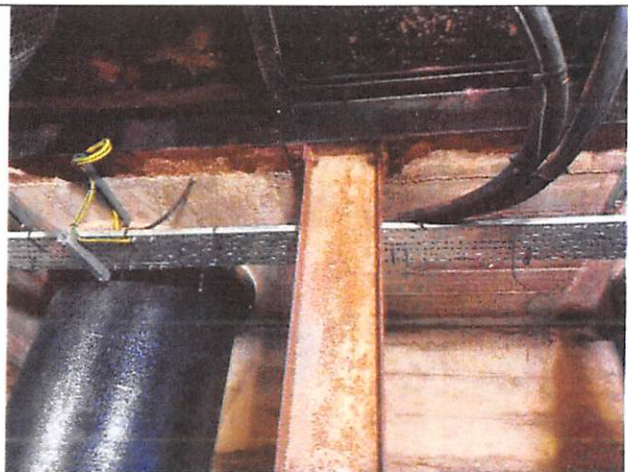
Photograph 9: Pump support steelwork and stanchion

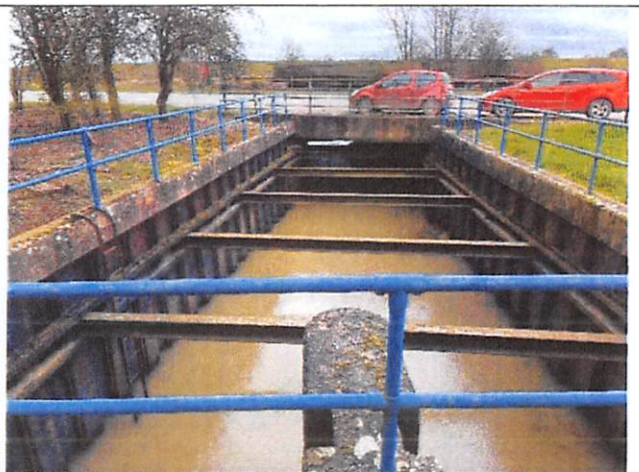
Photograph 10: Outfall

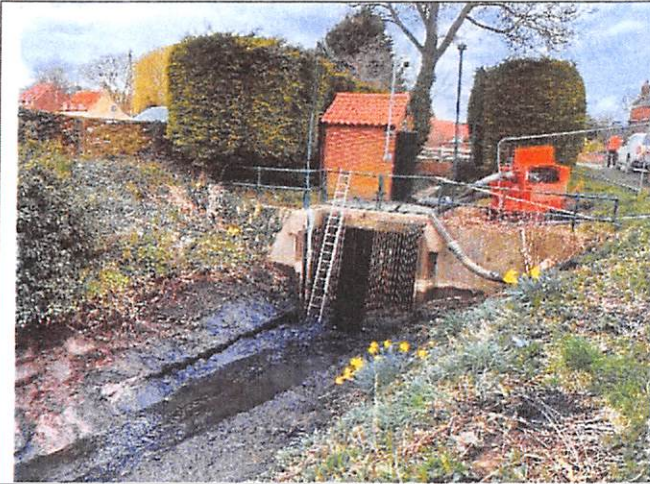
*The steel sheet piled walls of the inlet structure have corroded to an extent that they have reached the end of their serviceable life. It is unlikely that any numerical structural assessment could demonstrate their stability or any acceptable factor of safety.*

Photograph 01: Pumping Station Intake

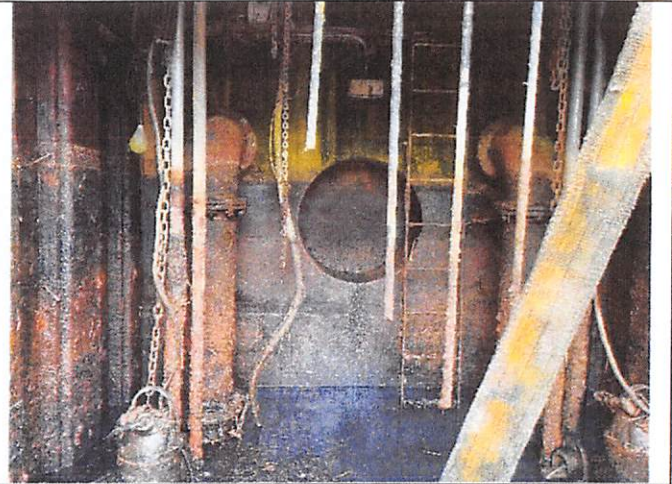
Photograph 02: Intake

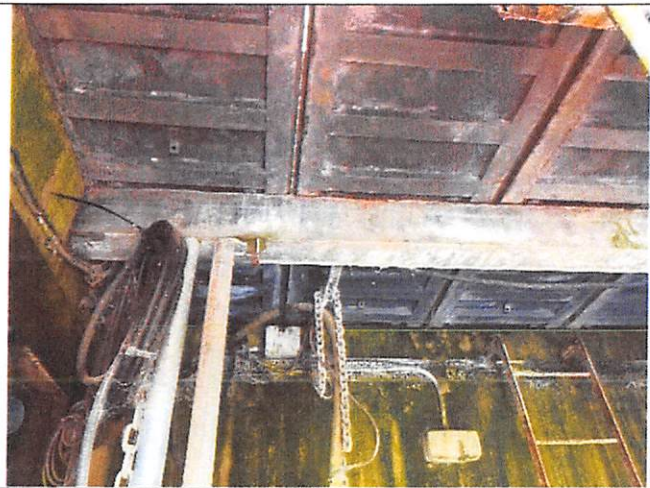
Photograph 03: Galvanised steel support beam (typical)

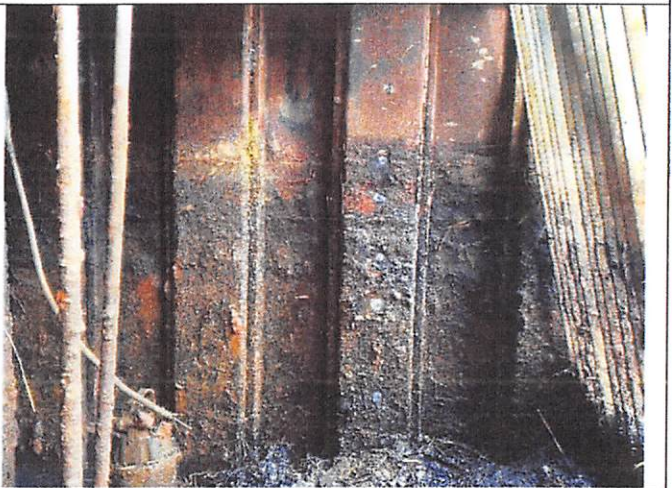
Photograph 04: RHS wall – test area

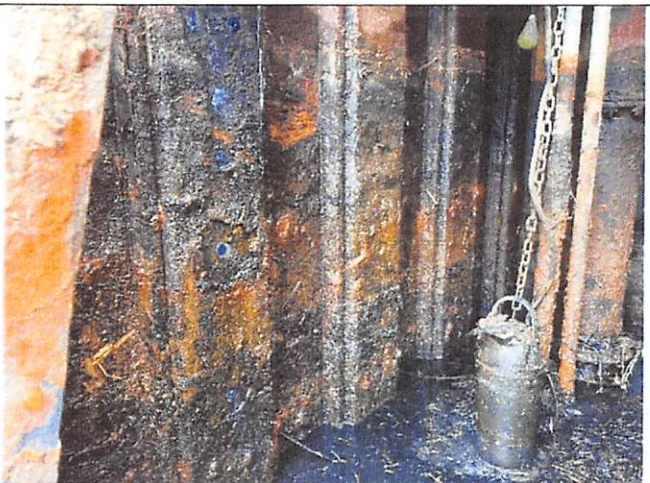
Photograph 05: LHS wall – test area

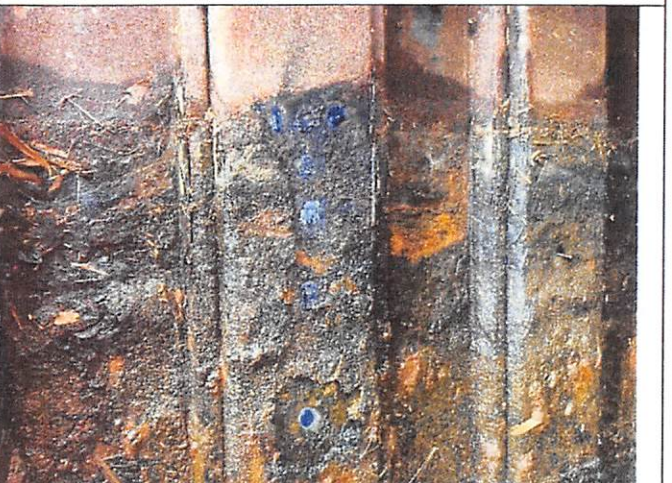
Photograph 06: Test area (wet/dry zone)
