### **Stakeholder Update: Lincolnshire & Northamptonshire**

Environment Agency Recovery Works Update  
19 December 2019

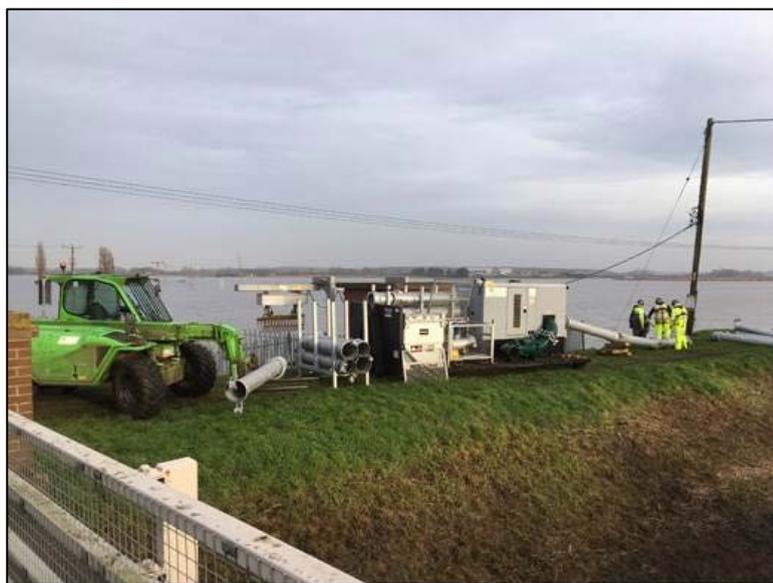
### Barlings Eau

- We have now completed the piling along the breach site and the bank slip.
- The floating equipment used for the work is now being removed from the water, and we are now de-mobilising from site.

- The next phase will be pumping the flood water off the farmland, once equipment has been removed from site.
- We have produced a pumping plan alongside Witham 3<sup>rd</sup> IDB and LCC Highways.

- Two high volume pumps have now been set up and are now pumping on site, on the embankments either side of Short Ferry Bridge. Two further pumps are planned to be installed on the road on Friday 20<sup>th</sup>. These pumps will be manned 24/7 and over the Christmas period. We anticipate it will take around 3 weeks to fully pump the water from the land, although this is dependent on weather conditions.

- LCC Highways will make the decision to reopen the road when it is safe to do so.
- We are in close contact with the affected landowners, regularly updating them about the repair plans and progress.

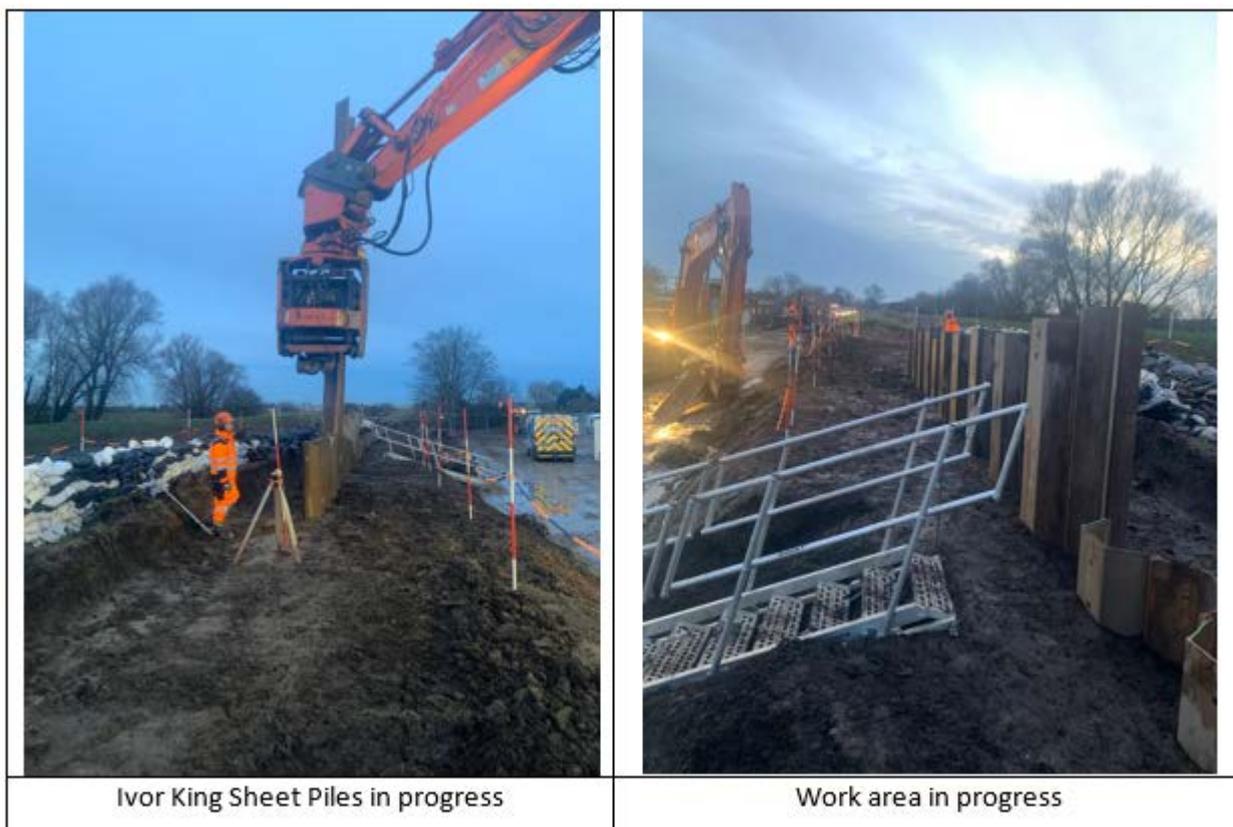
Billinghay Skirth, Adjacent A153 just outside North Kyme

- Seepage had occurred through the embankment.
- We have started to install piles this week as part of the permanent solution. We are monitoring the site carefully.
